**Lielstraupe castle,
Straupe, Straupes pagasts,
Pārgaujas novads, LATVIA
Cadastral nr. 4282 004 0263 001
National architectural monument Nr. 6275**

**ARCHITECTURAL-ARTISTIC
INVENTORY
OF THE LIELSTRAUPE CASTLE**

**VOLUME 1
TEXT, DRAWINGS**

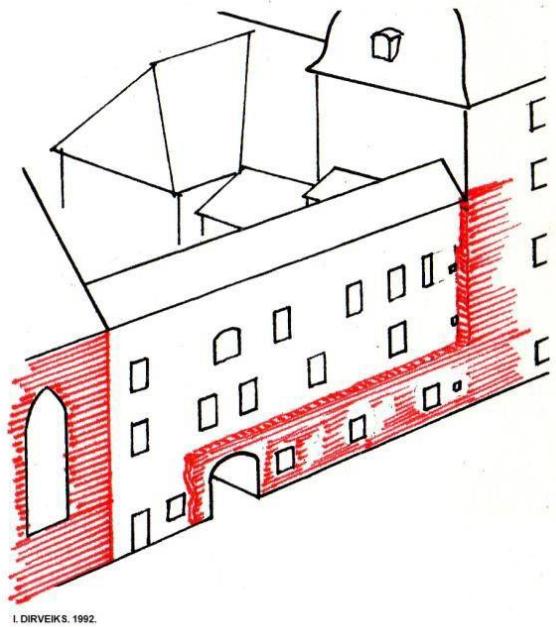
The oldest structure (brick wall in Wendish bond) in the ZA wall of the church and the castle. At the level of the 3rd floor and attic of the ZA building, the "tower" has been added to the existing wall.

shows a horizontal relief border, which is supposed to be an extension (top edge) of the mentioned wall. An extension ("shelf") has been found in the surrounding wall, approximately at the floor level of the 4th floor of the tower.⁸ In order to determine the possible continuation of the surrounding wall on the ZR side, additional broader structural uncoverings should be made. The side walls of the tower window openings have unusually deep niches that are not functional. Perhaps this structure may provide a reply to the fact found in 1992 that the ZA exterior wall and the tower were separate structures.

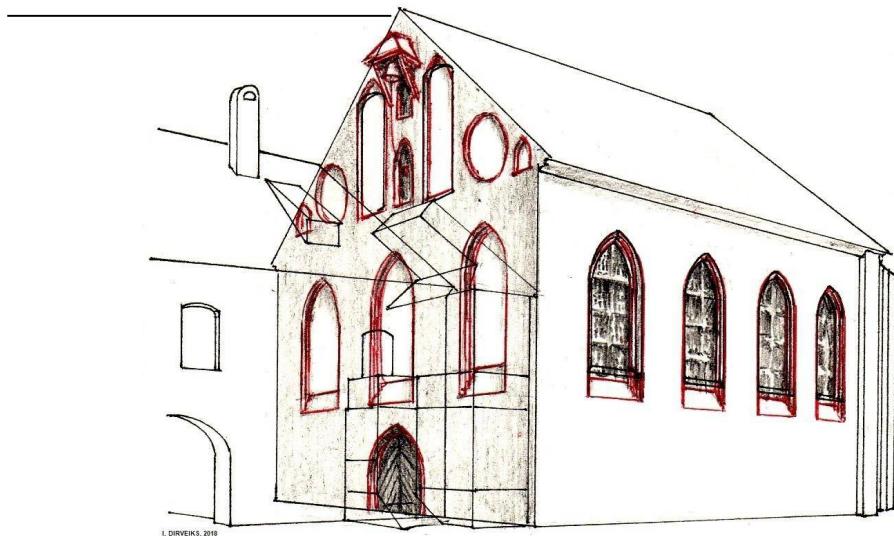
ZR façade of the Straupe Church in the 15th century. Theoretical reconstruction. I. Dirveiks. 2018.

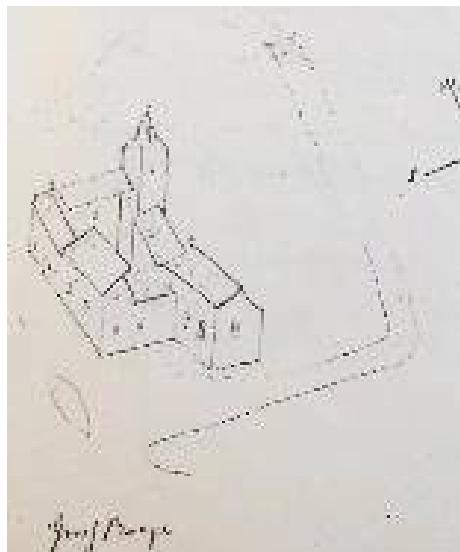
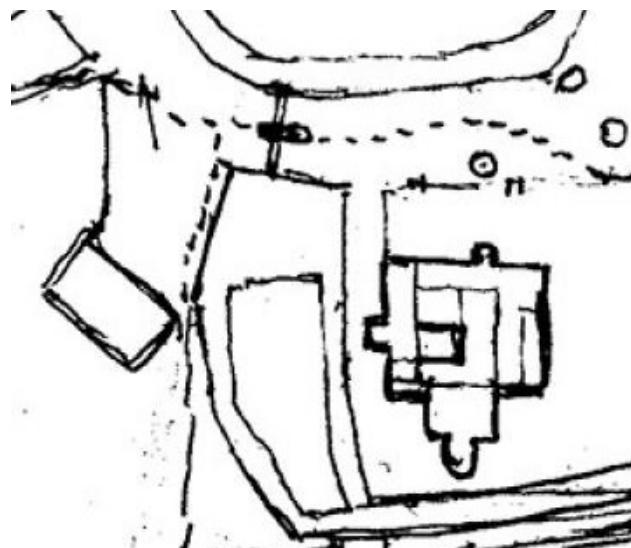
On the left: Redrawing from the 1683 Swedish map (fragment with the castle, the church).

The oldest known real representation of the castle and the church.

the pyramidal roof and ZA gate. Of particular interest is the DR side building, which is supposedly inside the surrounding wall. Given the conditionalism of the drawing, the current DR building may also be depicted. This guess can only be verified by archaeological excavations inside the surrounding wall. Another redrawing from the 1683 Swedish map (fragment) is a sketch of the oldest known real plan. This drawing is also very conditional and sketchy, but it allows to distinguish between the church with the chancel, castle buildings around the inner courtyard, the wall containing castle-front, ponds and household buildings.²⁶

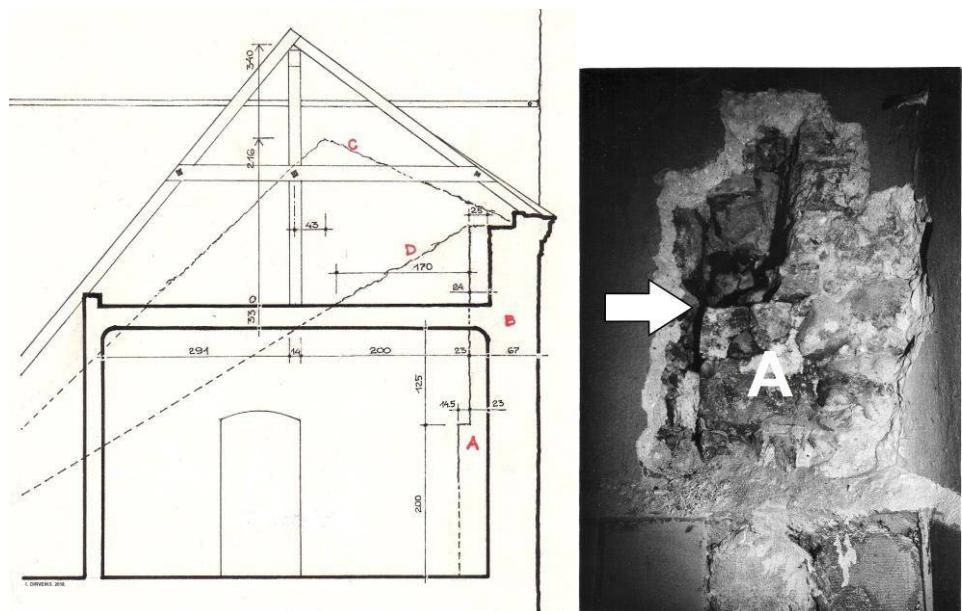
Changes in the shape of the ZA building's roof can be found on the tower façade according to 1992 and 2018 research results.
I. Dirveiks.

A – the 14th, 15th century ZR defensive wall with extension “shelf” (the wall dried in the beginning of the 19th century). The photo shows the “shelf”. B – the ZA building's walls and ceiling structures built in 1906/09. C – the 18th century roof (shown on the J. C. Brotze's drawings). D – the older undated roof pitch.

The older roof contour can be found on the tower wall in the ZR building attic. The 1905 photograph of the burnt castle also shows it well. The ridge of this roof, which existed in the 17th century, was ~2 m lower than of the current roof, which is at the same height as the one built in the 18th century. A 17th century pediment masonry that is by ~30 cm thicker has remained in the lower part of the DR end pediment masonry.

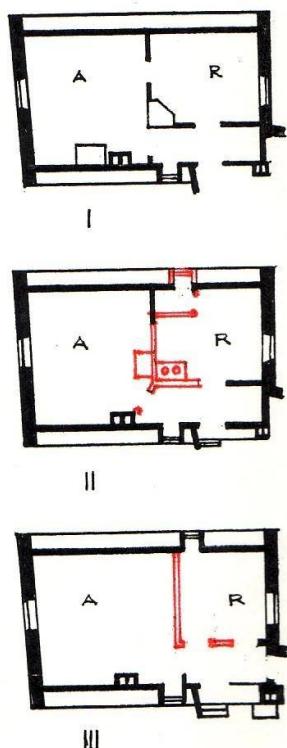
Changes in layout of the DR building
attic floor in the 20th century.
I – 1909. II – 1941. III – end of
the 20th century.
In accordance with the 1992.
research results.

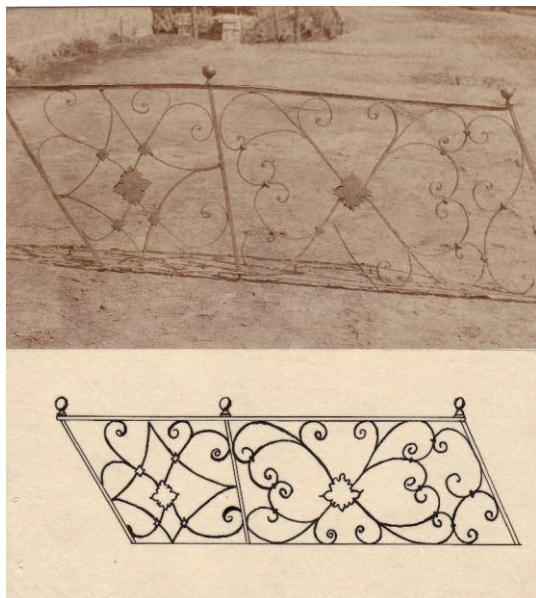
Photo and sketch of the main entrance stair railing.

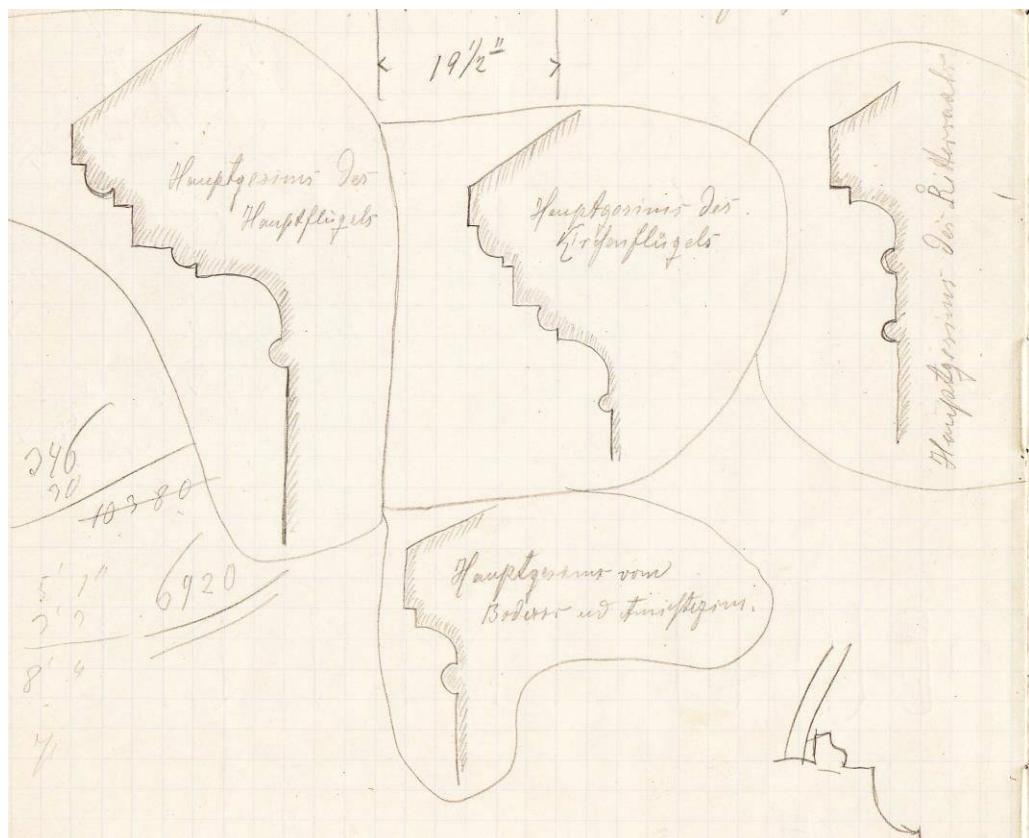
Sketches of cornice profiles. W. Bockslaff. 1906.
Source: RTU AF archive

The small gathering in the W. Bockslaff's archive contains pencil sketches of all three building cornices.¹⁰¹ It can be seen that the shape of cornices of both ZA and ZR buildings is a variation on the 18th century analogues that can be found in Latvia. The cornices on the façades are highlighted with white painting.

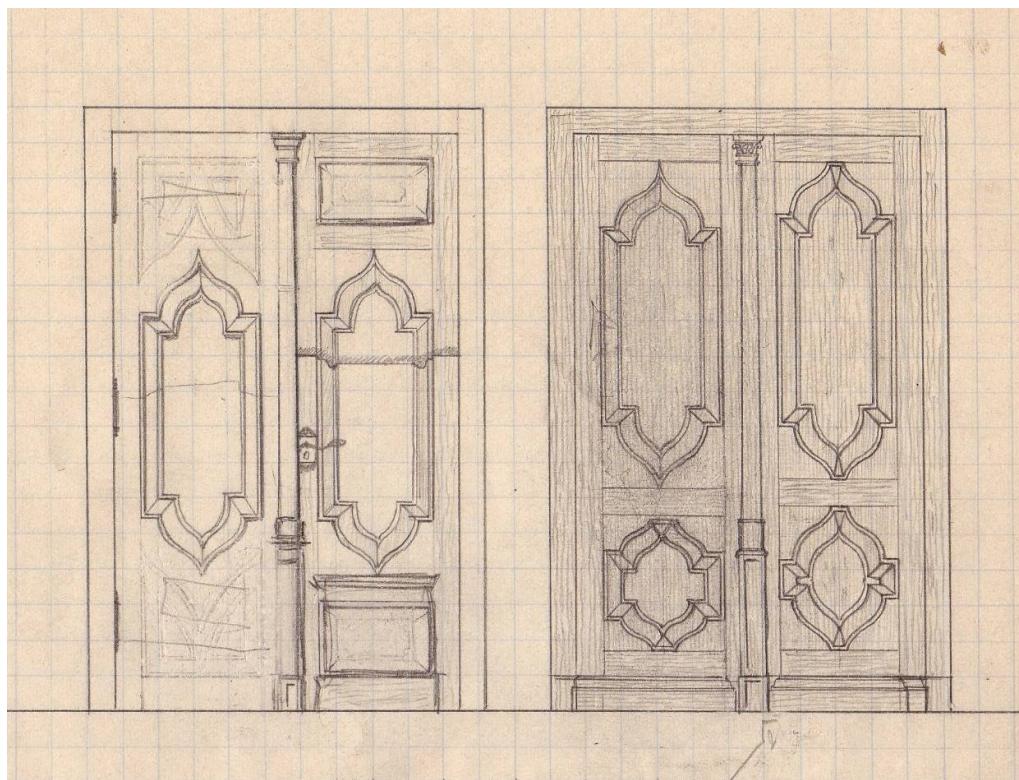
Sketch of entrance doors. Unimplemented versions.

W. Bockslaff. 1906.

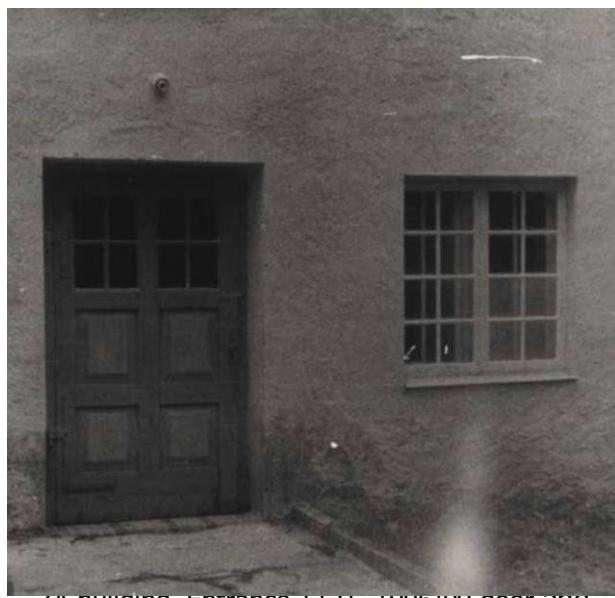
ZA building. Entrance T121. 1906/09 door and window.

Ozoliņš's photo. 1952.

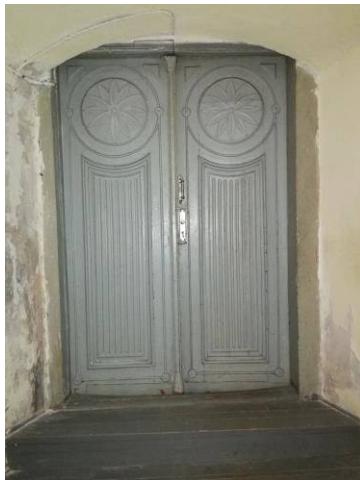
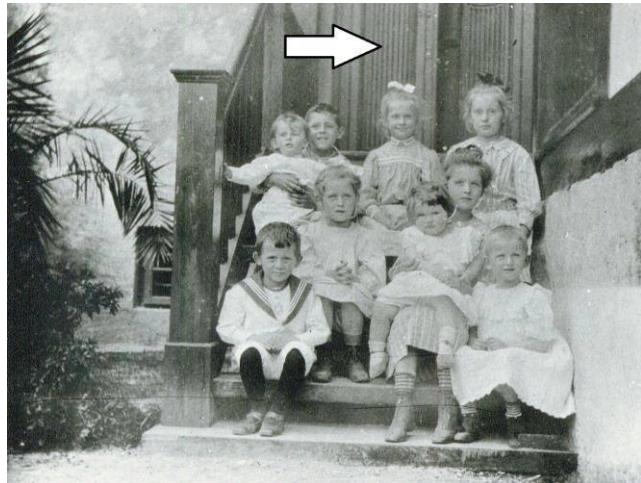
In 1909, the current door leaves of the church's R entrance were the entrance to the ZA building from the so called "thieves' stairs". This shows a photo taken around 1909.
Source: Georg Solms' archive.

A photo taken around 1910 shows that there is the entrance from the so-called "thieves' stairs" in the corner of the church to the ZA building and that there are the door leaves in the opening, which in the second half of the 20th century, when the ZA building was adapted to the needs of the hospital, were relocated to the R entrance of the church, where they are currently located.¹⁰⁹ Stylistically, these leaves can be attributed to the middle and third quarter of the 19th century and are very different from the neo-baroque doors in the rest of the castle designed by W. Bockslaff. Only research of the doors can answer whether they were really made before 1905.

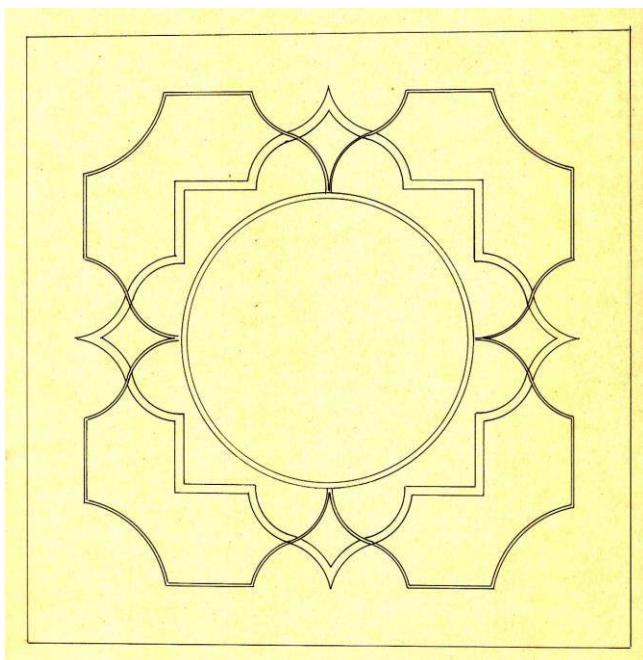
A sketch of the plafond. W. Bockslaff. 1906.
A similar plafond with an 8-star star in a round rosette is in the dining room. *Source: RTU AF archive*

by the fact that after the burning of the castle the owner Hans von Rosen asked for permission to use the Ungurmuiža's so called Great Room ceiling rosette as a model for the restoration of the lost Lielstraupe décor. The owners of Ungurmuiža did not want it to be copied accurately, and W. Bockslaff had to create stylistically similar imitations.¹¹⁰

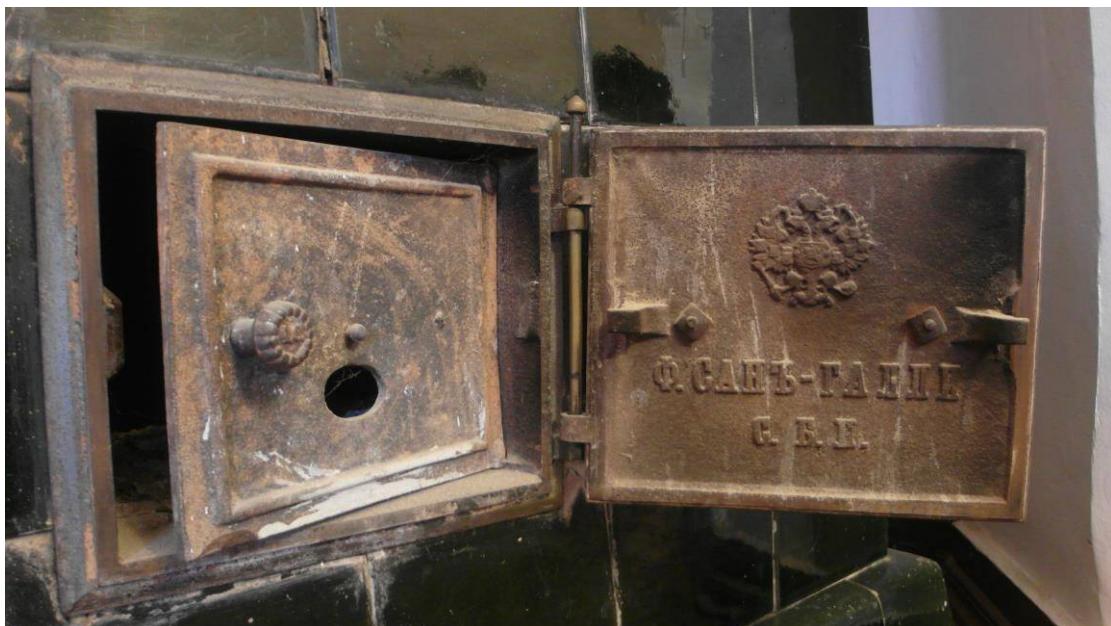
Original doors have remained for the T104 stove.

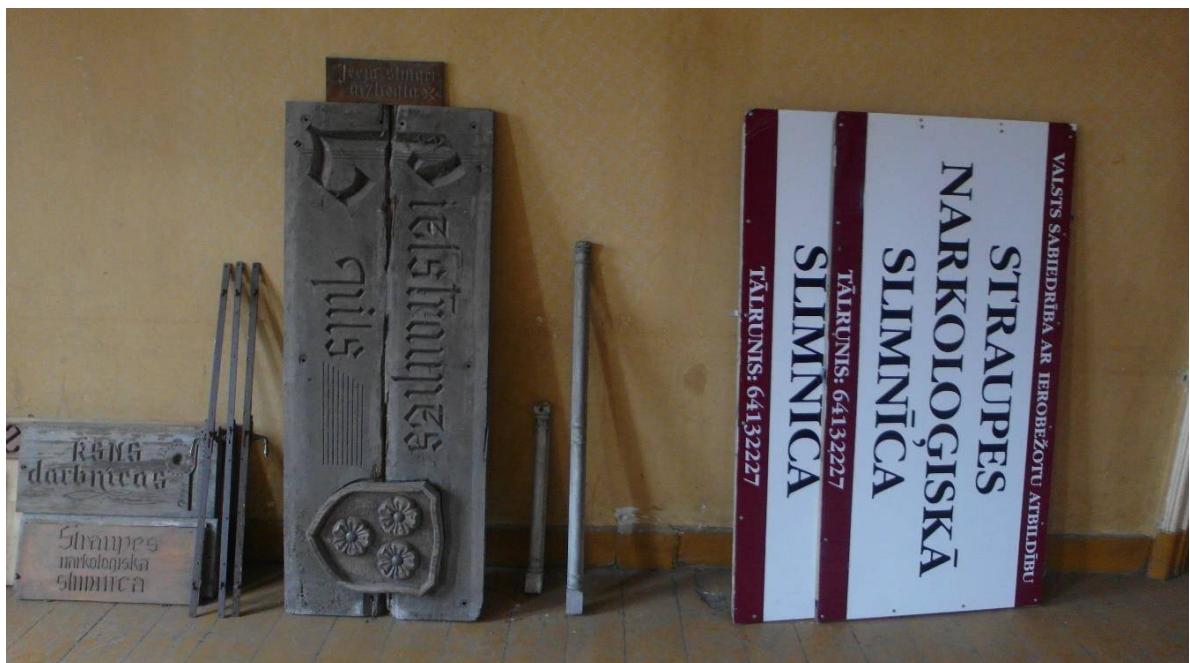
Artefacts from the time when the castle housed a narcological hospital, parts of window fasteners and pilaster-like rabbets from windows replaced in the ZA building.
